Dear Andover Norton Customer,

How to fit an exhaust pipe to a cylinder head: Norton

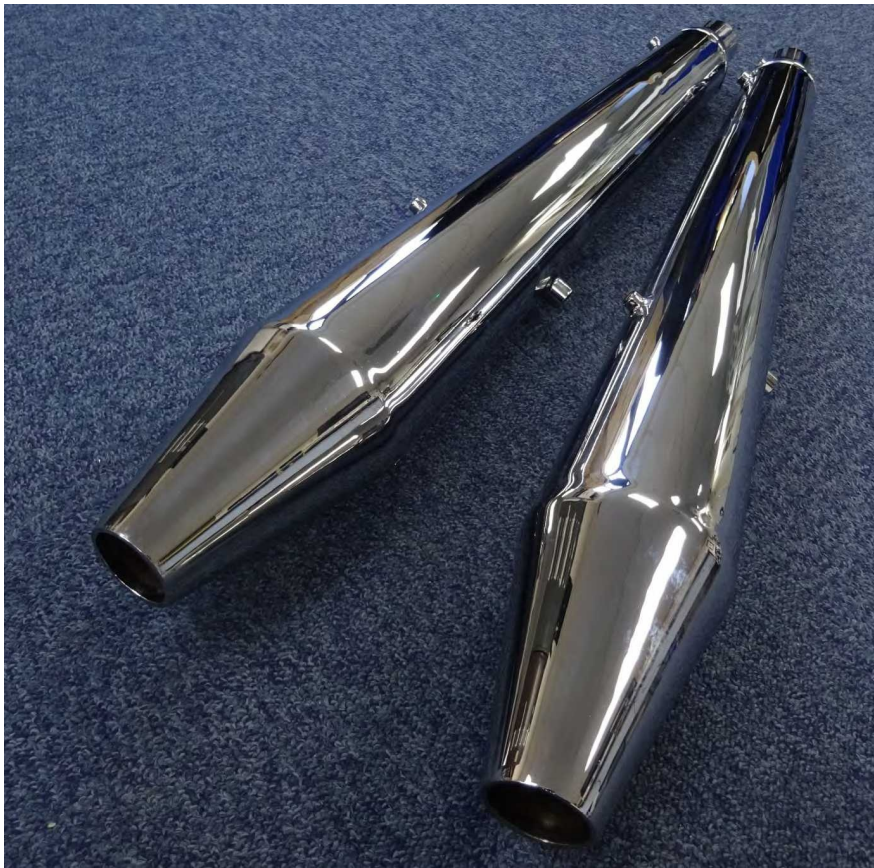
"S"-Type silencers, pair, 06.1312/X

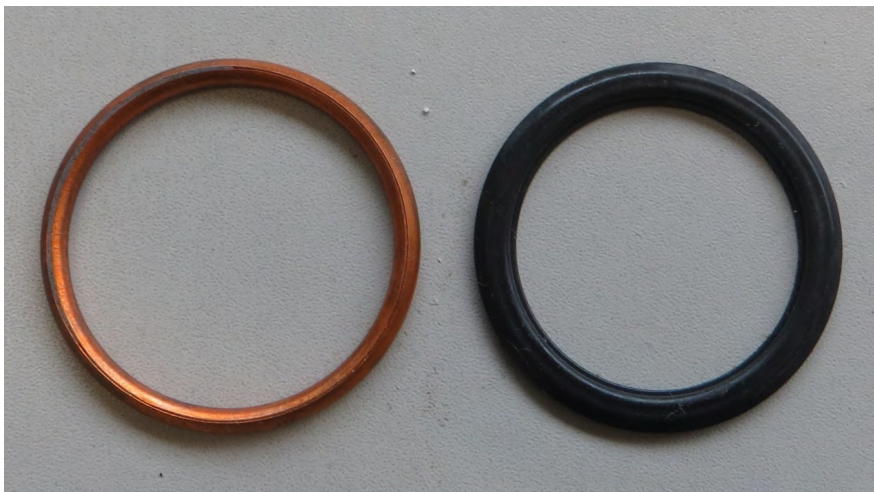
Above: Old & cheap variant on the left, the good stuff on the right. The good ones you put with the flat towards the exhaust valve into the cylinder head exhaust port.

On 750 Commandos, and all other Norton Twins but the 850s, this is easy enough. First you put the sealing washer 06.3995 in the cylinder head. In early days these were a copper-based thingy that squashes to paper-thin and isn't all that good. These beasts are found in pattern gasket sets even today. ANIL have used the better steel variety for decades:

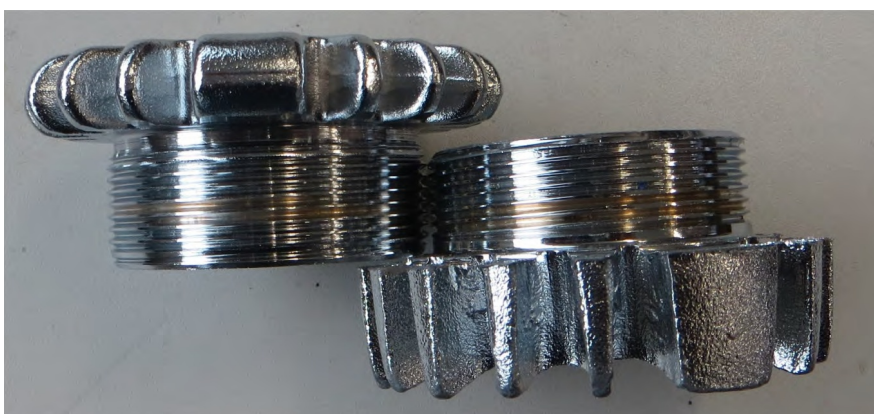
750 nut with longer thread on the top, 850 with shorter on right.

Why is this so? Easy, the 850 needs to go over the bellmouth end of the pipe, so unless something then goes inside the nut the exhaust pipe will easily fall off. Hence the 850s have an internal diameter reduction part, called the “retaining collet” (part# 06.5260) that reduces the internal diameter of the nut so it can press on the “bellmouth” end of the pipe.

1. The 750 nut is longer than the 850, so if someone used the 850 nut on 750 pipes the nut will not tighten the 750 pipe down properly. Some try to compensate with a number of exhaust sealing washers. The only proper way to fit the non-balanced pipes is to use either the exhaust lockring 06.2464, or the 1973 only exhaust nut 06.3555 which looks like the 850 lockring 06.3988 but has the longer thread.

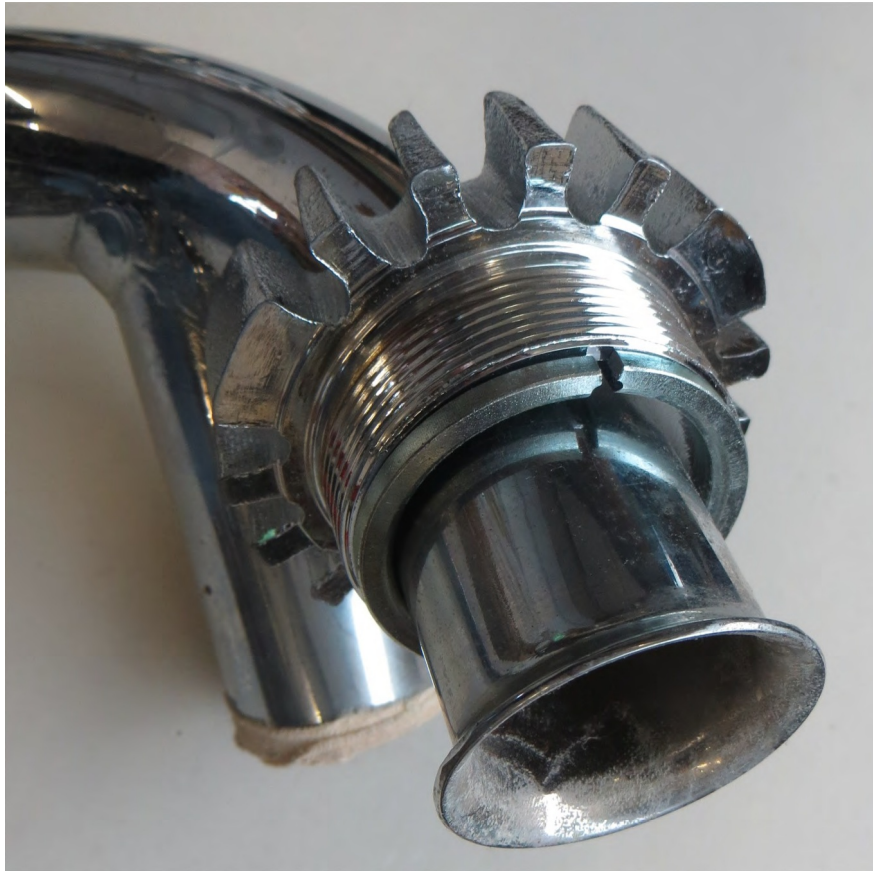
850 exhaust nut (part# 06.3988) and retaining collet (part# 06.5260)

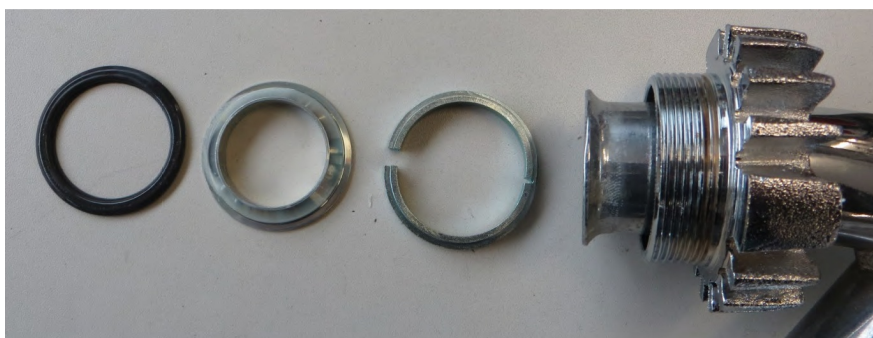
The whole package: #06.3995, #06-5259, #06-5260, #06.3988, fitting 06.5256/7

In order to keep that bellmouth in shape that then takes the “spherical seating” (part# 06.5259) which forms a gas seal at the same time. This then presses on sealing washer (part# 06.3995) and thus fully seals the exhaust pipe.

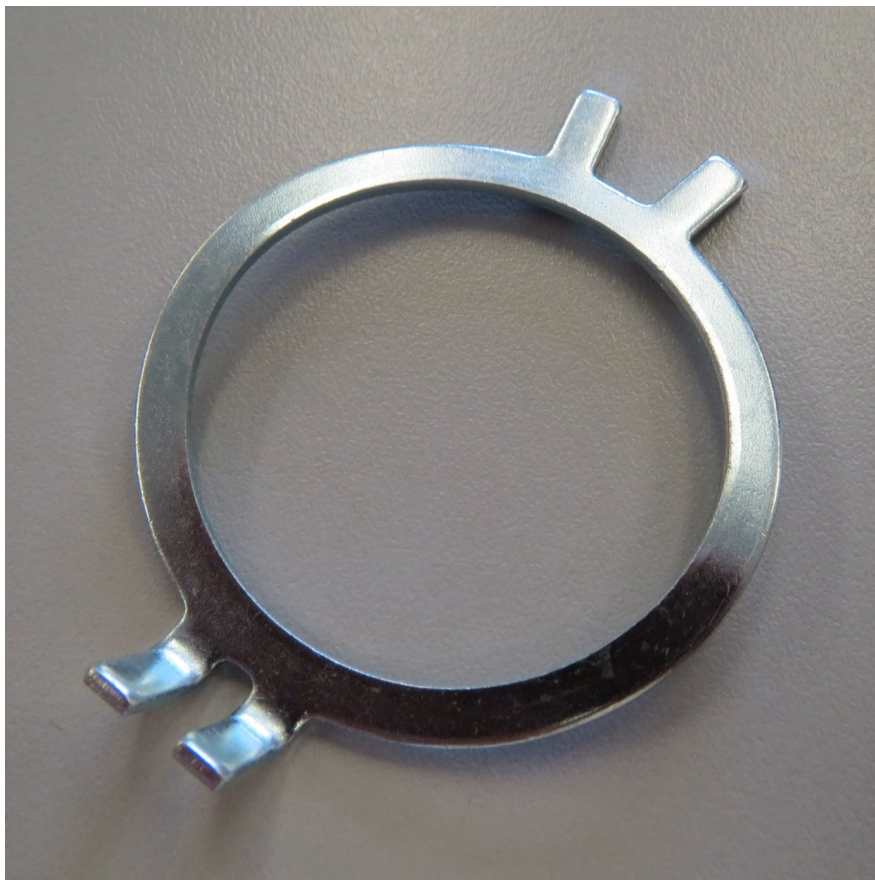
Part# 06.2412. Again, these are only bent into the exhaust locknut with the straight "tongue" when the exhaust pipe has been on for a while and the exhaust nut is in the final position. The bent tongues embrace a cooling fin.

Secondly, people wire exhaust nuts up. This means drilling nut and a fin in the cylinder head. Not good, in my opinion (and the late and great Mick Hemmings hated it, too!) so I use the exhaust lockwashers 06.2412 on my Commandos.

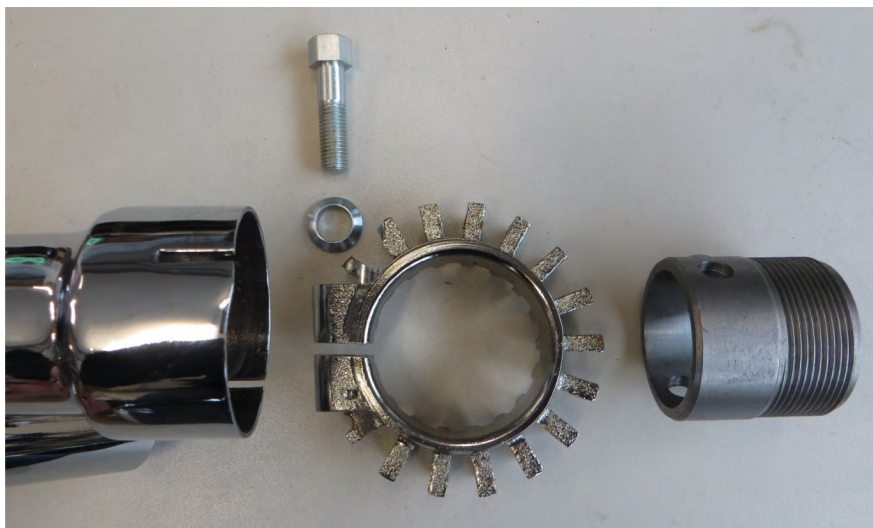
Above: push-over arrangement on late 650 & 750s used bolt part# 70.6744, conical washer part# 70.8860, clamp part# 71.0216 and sleeve part# 70.9516.

A steel sleeve is screwed into the threaded exhaust port on the cylinder head and the pipe then pushed over it (hence the name) and is clamped on with a steel clamp.

This arrangement actually works very well and was suitable for single downpipes as well as downpipes with balance tubes. Triumph became part of BSA and in 1971, with the new "Oil in Frame" chassis developed in "Slumberglade Hall ", the BSA/Triumph R&D centre, some clever accountant had the idea Triumph could adopt BSA's cheap and nasty method of fitting pipes to a cylinder head. This was the "push in" method:

Comparing the push-over picture with the push-in variety makes it crystal clear why the accountants thought it was brilliant. Instead of casting, polishing and chromium plating the push-over exhaust clip, having the special bolt and the special washer made and plated, making the steel exhaust sleeve and cutting a thread into the cylinder head they just bored a plain hole into the head and cast a cheap ally decoration.

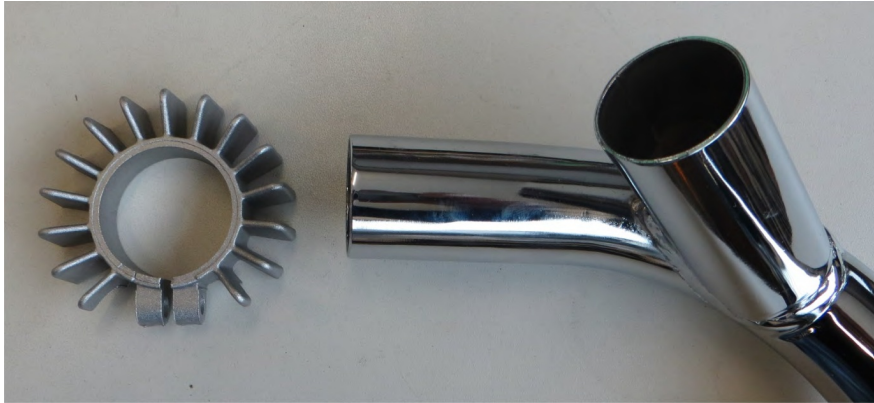
It is easy to see why it appealed to the number crunchers. A cheap ally "design" clamp held on by a norm ally (thus again cheap) bolt and nut masked the atrocity of an exhaust pipe just pushed into the head, relying on the balance pipe to keep the exhaust pipes, forming the top ends of an "A", in the head and hoping this arrangement would not become sloppy with wear through vibration within the then very short warranty period.

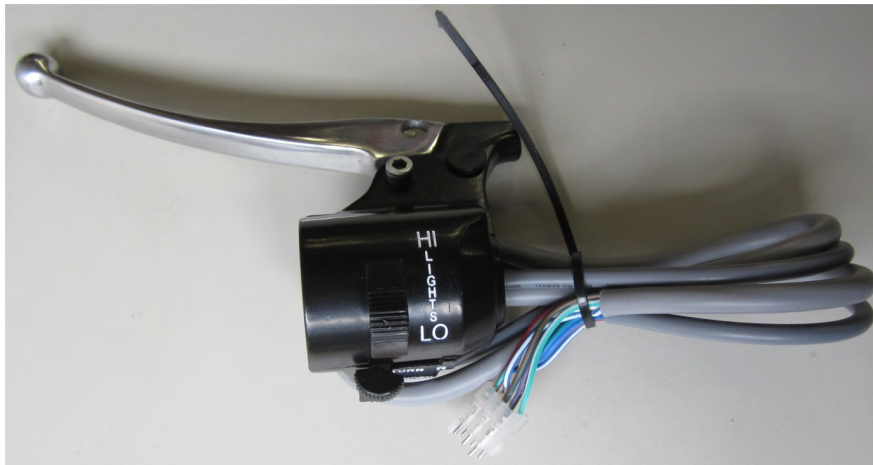
The Mk3 switch discussed. I remember on my own Mk3 the metal plate- I call it tongue- on the switch was some copper-based metal that corroded and wore easily. When I repaired mine in the 1970s a friend made a new "tongue" from stainless that then lasted. Joe S.

It has been many years since I was last in the switch to repair the indicator mechanism. The repair is relatively easily but care needs to be taken so no parts are lost. Once the switch gear is removed from the handlebar you can then see the metal plate with the lever which moves left and right. This can be removed easily by removing the 3 screws, **BUT BE CAREFUL WHEN YOU LIFT IT AWAY, IF THE NYLON BLOCK UNDER COMES WITH IT THEN THE SPRING AND LITTLE BLOCK WILL FLY OUT.**

The main parts that wear are the little metal sliding block and the 3 contacts in the circuit board. A new sliding block can be made with Swiss files and the 3 contacts can be cleaned and built up with solder. Never try to rush soldering, always use the correct power soldering iron and always give plenty of time to ensure the soldering iron is fully up to temperature. When it is, you can work quickly and not damage the circuit board.

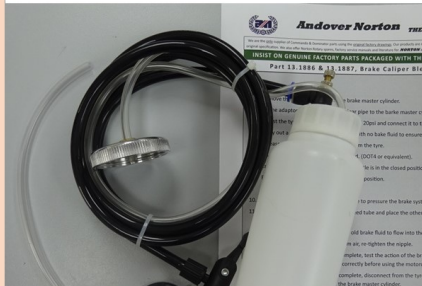
The master cylinder cap is temporarily replaced by a new cap supplied in the bleed kit.

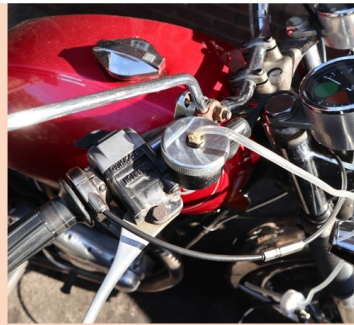
**Part 13.1886, Brake pressure bleed kit, Commando
1972 to 1974, £39.50 + vat/carriage.**

**Part 13.1887, Brake pressure bleed kit, Commando
1975 to 1978, £39.50 + vat/carriage.**

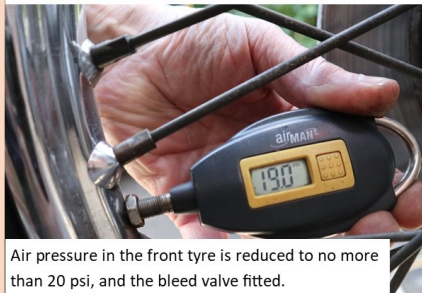
Air pressure in the front tyre is reduced to no more than 20 psi, and the bleed valve fitted.

After checking the system is air tight, the bottle is filled with brake fluid.

A screw valve on the bottle is opened to pressurize the master cylinder reservoir.

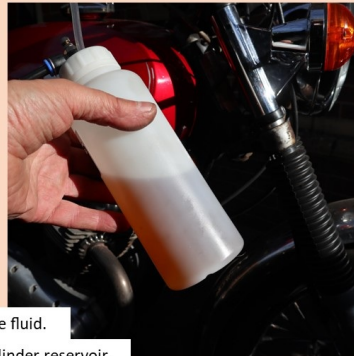
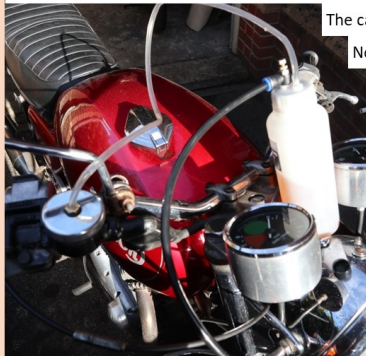
The caliper bleed screw is opened. Bleed until no air bubbles appear.

No brake lever pumping is required. Fluid emerges under pressure.
