Dear Andover Norton Customer,

Joe's Mercury:

Joe's TT/F1Sport "Lydia"

Joe's C652 ex-press bike

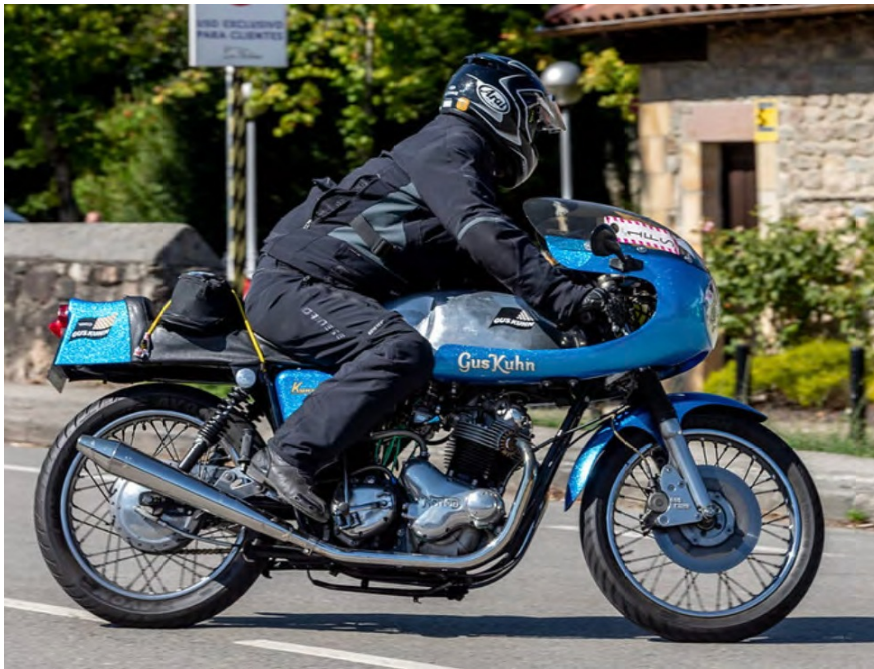
"Hi, great to read about the Gus Kuhn bike and the history of the bike. My own Gus Kuhn Commando has an interesting history not raced as far as we can tell but a factory developed bike exp1010 fjb stamped on head and crankcase was eventually sold to Trevor Ireson TT sidecar ace from Swindon."

"1010" I know as an experimental rotary factory bike that went through many development stages and is still about. Whether this here machine was a development bike I do not know and I suspect the "FJB" stamp could mean a rebuild by Fred Barlow, in the 1980s known as supposedly an expert on Norton twins.

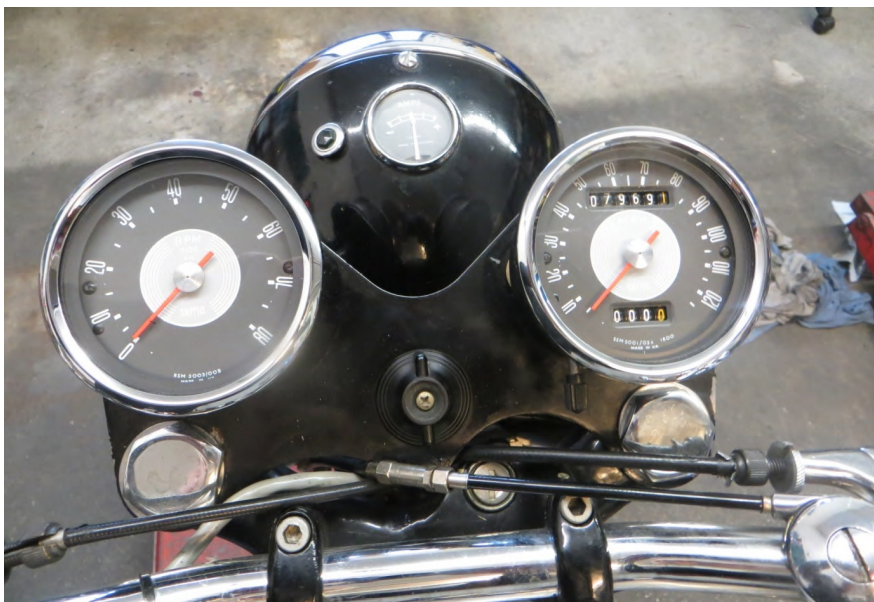
The Mercury runs fine but from when I bought it till now the instruments always gave unrealistic readings. Whilst the road speed indicated on the speedo was on the VERY optimistic side, the revs showing on the tachometer were unrealistically low and did not seem to go up beyond 3.500RPM though the exhaust note changed significantly. At long last I sent the instruments to a chap who repaired other to my satisfaction in the past. I now have them back and installed and look forward to testing them on the road as soon as weather and salt-free roads allow.

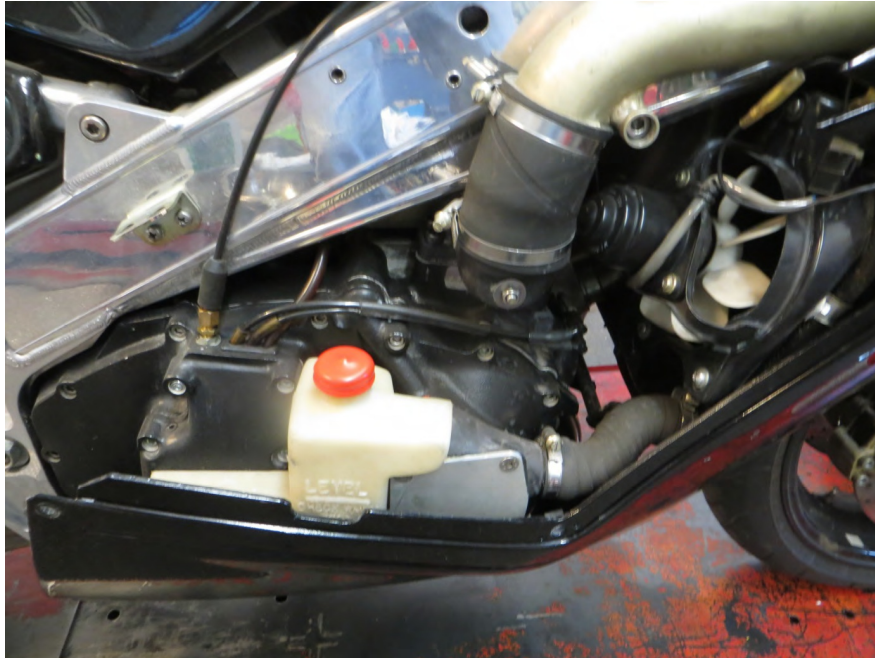
"Lydia" on the workbench. Water pump sits in front of the white plastic tank.

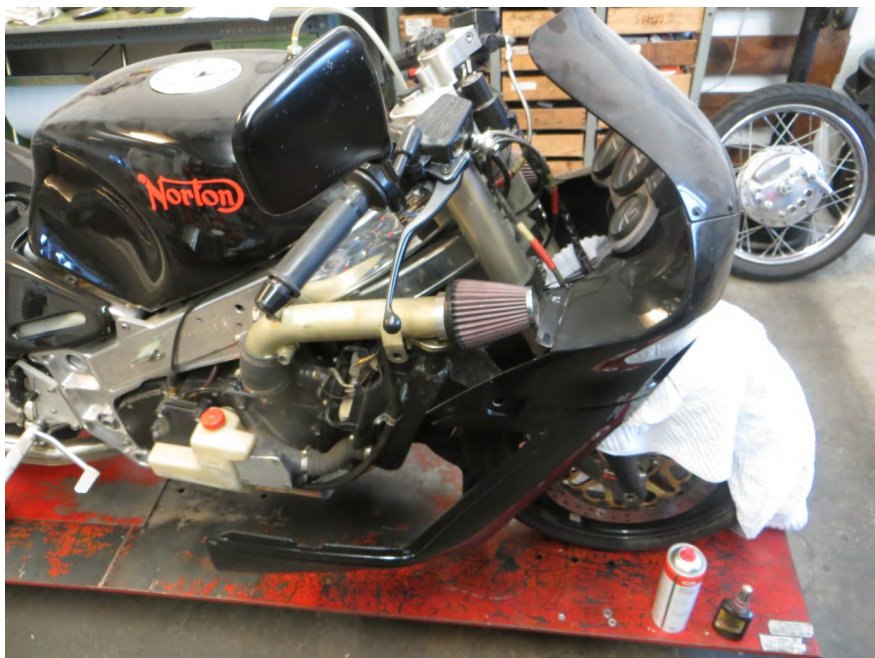
"Lydia's" front fairing put forward as to allow access to the water pump. White towel on front mudguard stops scratching the fairing.

Getting at the pump on a fully-faired motorcycle is not as easy as on a "naked" bike. After removing the trim panels and the side covers the main fairing needs to be taken out of the way. That main fairing shell is now held on by the front indicators that are fitted to the induction pipes. Take the indicators off and the fairing moves forward and then rests on the front mudguard. It is therefore advisable to put a piece of cloth on the front mudguard to keep the fairing from getting scratched.

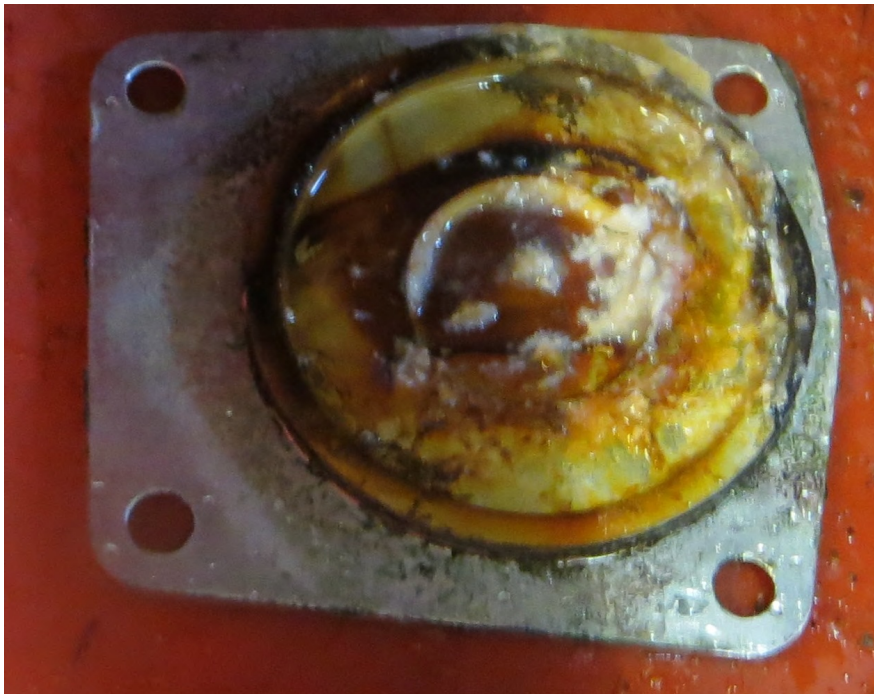
Before I took the pump off I removed the cover and, looking at it in the water tray, revealed sludge in its worst form.

Above: Water Pump Cover with Sludge.

Richard Negus, after seeing the pictures, said: "***That's one of the problems for aluminium water-cooled engines. The coolant additive not only protects from freezing temperatures but also reduces corrosion of the castings. Ideally, the coolant should be replaced every 1 - 2 years.***" He advised me how to clean the water pump including the impeller, then went on: "***Check the water passages in the pump housing, clean as necessary. Next is to clean the engine and radiator, There is a solvent to add to the water system which is supposed to dissolve the sludge, but you may have to do it several times.***"

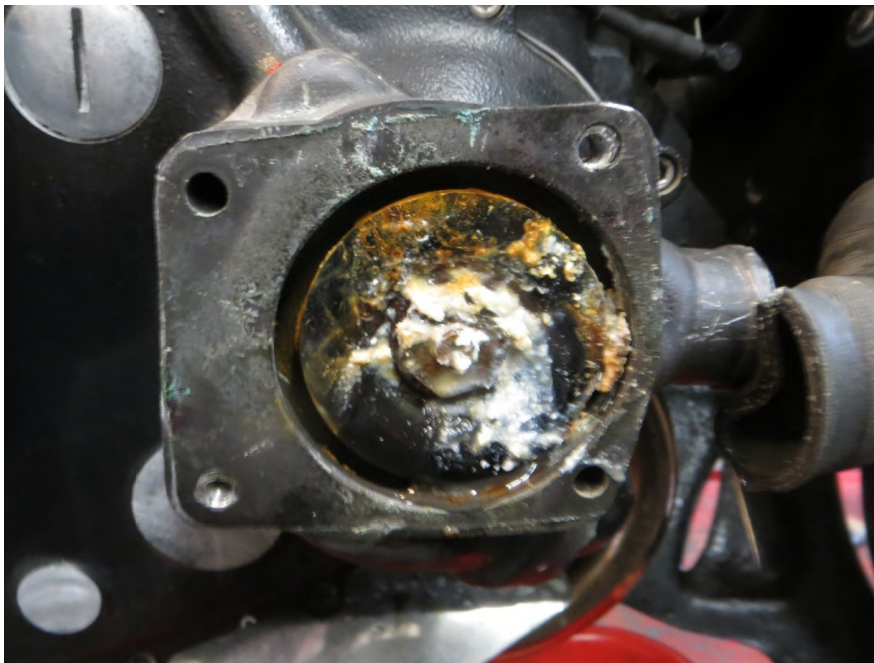
The back of the impeller didn't look any better, but then this is no doubt my fault.

Oh Dear! Impeller doesn't look like it was fit to pump water.

After taking the impeller off its shaft my hope the impeller's fins might be full of sludge and thus unable to pump water failed. The impeller was basically fine with a bit of residue on it, so I have a blockage somewhere in the system. Richard Negus again: ***"Before you use radiator flush, use a hose pipe to wash the loose stuff out. The main castings have bigger water passages but I've still seen centre plates blocked, only found when stripping an engine."***

I have now ordered a solvent for the cooling system and some wonderjet that uses water plus air pressure a German motor parts wholesaler offers specifically for blocked cooling systems. I will report on the results but may have to wait for warmer weather before I start the dirty operation out in the yard!

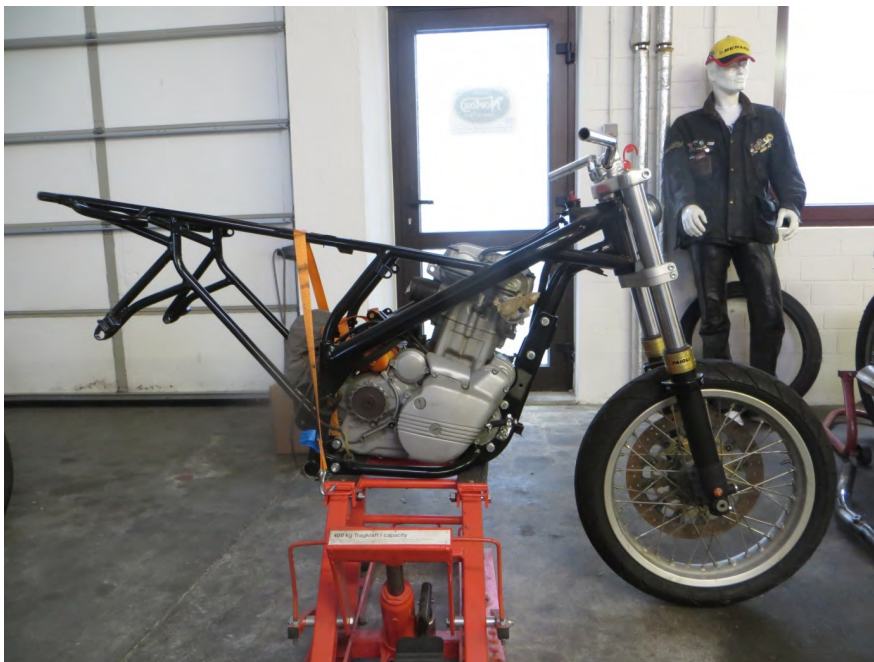
The C652 starting to look a bit more like a motorcycle. Dummy in background sports my old leather jeans from the 1970s and my old Barbour "Leonid Breschnew Replica" jacket with the masses of now vintage pins and stickers.

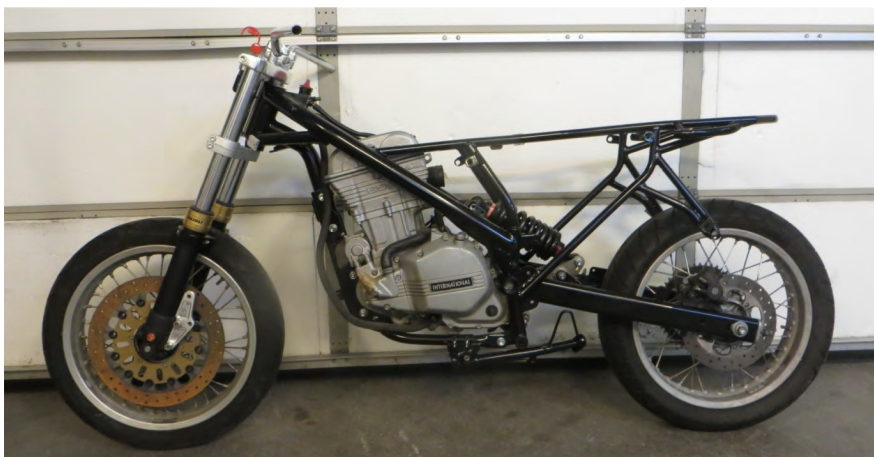
Our 1998 press bike on two wheels again after over a decade....

Since the "Source" draft took longer than anticipated due to an unexpected order overload I had another Sunday in the workshop, putting new needle bearings and seals in the swinging arm, getting the swinging arm back into the frame (handmade frame, remember? Not everything lines up perfectly at a first attempt!) plus the cantilever rear suspension and the rear wheel. Again, searching for certain parts in the bins neglected for over a decade took more time than anticipated, but in the end I got everything together and it was rewarding to have the poor old press bike on its own two wheels again after all these years. Next will be an overhaul of the carbs and installation of airbox and carburetors. Meanwhile the headlamp brackets are away for welding the instrument console brackets on.
